# DIAGNOSTIC OF OPERATIONAL CONDITION OF GEAR COMPONENTS IN WINDING HEAD DRIVES USING VIBRATION ANALYSIS METHODS

PETR BARON<sup>1</sup>, JOZEF TKAC<sup>1</sup>, MAREK KOCISKO<sup>1</sup>

<sup>1</sup>Technical University of Kosice, Faculty of Manufacturing Technologies with seat in Presov, Slovak Republic

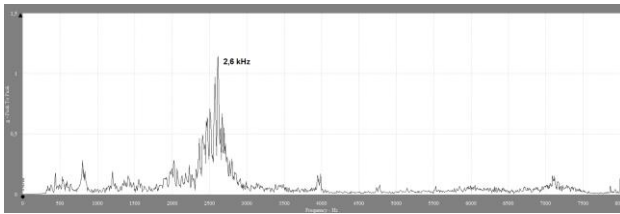
The FFT spectrum recording (Fig. 3) indicates a high amplitude at the gear meshing frequency. This is a sign of rotor component damage. The condition is unsatisfactory, and repair or replacement of the rotor is necessary. An identical measurement was conducted after replacing the damaged component – the gear pinion of the winding head

**Figure 2.** FFT Acceleration spectrum – indication of gear pinion damage on the rotor

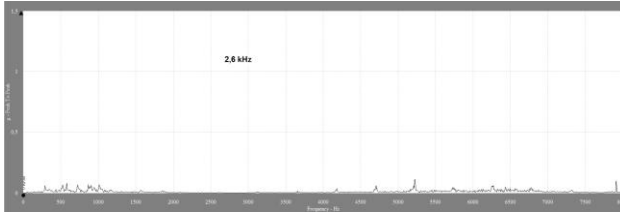
drive rotor (Fig. 3). In this case, the FFT spectrum shows no dominant amplitude, i.e., no indication of damage. The time record identifies an increase in the signal from the damaged tooth surfaces of the rotor gear pinion. Such a condition must be evaluated as unsatisfactory - indicating that pinion replacement is necessary (Fig. 4).

**Figure 3.** FFT Acceleration spectrum after replacement of the damaged rotor pinion

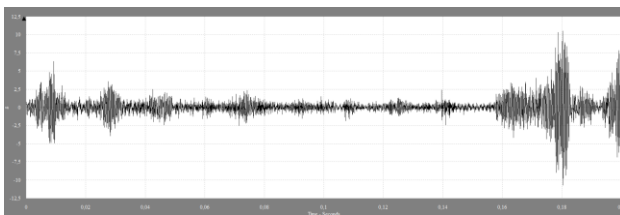
**Figure 4.** Time record of Acceleration (g PtP) before component replacement

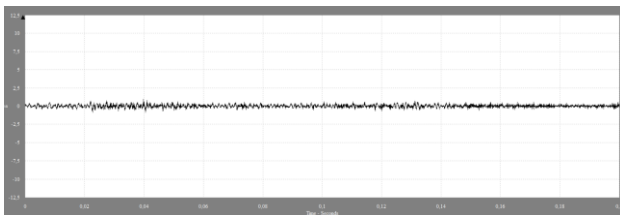
After replacing the damaged component, the time record indicates trouble-free operational condition of the rotor (Fig. 5). The measured signals are within the recommended limits.

**Figure 5.** Time record of Acceleration (g PtP) after maintenance intervention

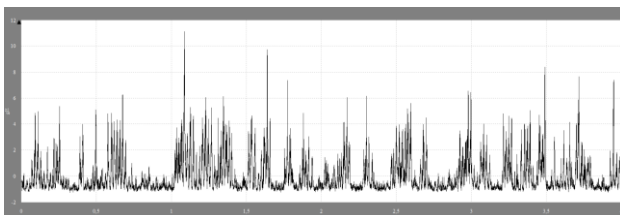
The time record of EnvAcc (gE PtP) allows real-time analysis of machine component conditions, identification of recurring impulses (e.g., damaged gear teeth or faulty bearings), and provides an indication of the equipment's condition based on defined alarm thresholds. The EnvAcc time record clearly indicated a periodic increase in signal amplitude, which was a sign of damage to the rotor gear pinion (Fig. 6). After replacing the damaged component, vibration amplitudes were significantly reduced, confirming the restoration of the equipment's proper operational state (Fig. 7). This method is therefore suitable for monitoring the operational condition without the need for equipment disassembly.

**Figure 6.** Time record of EnvAcc (gE PtP) – before maintenance intervention

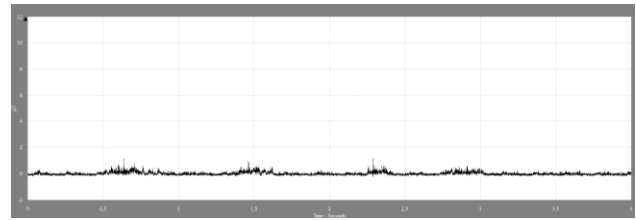
After replacing the damaged component, the time record indicates a good operational state of the rotor. The measured signals are within the acceptable range, but small, periodically

recurring signal deviations can be observed. This condition may also be caused by geometric inaccuracies of the rotor gear pinion teeth.

**Figure 7.** Time record of EnvAcc (gE PtP) – after component replacement

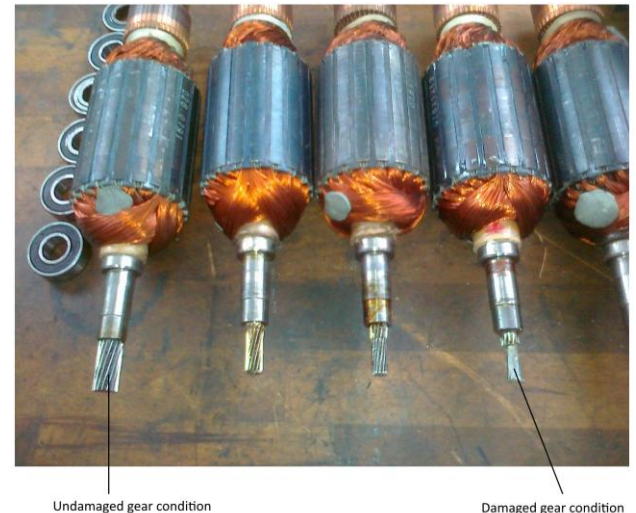
**Figure 8.** Types of damage to the rotor gear pinion

For some pinions, increased vibration signal values were recorded after component replacement or repair, attributed to manufacturing inaccuracies of the gear teeth or improper alignment of the pinion and gear, specifically excessive or insufficient gear backlash. These inaccuracies and misalignments can be sources of high-frequency vibration signals and may negatively affect the operational reliability and service life of the gearing.

- Verification of the gear manufacturing process should be carried out for both the gear pinion and the gear wheel. The verification should include an inspection of fundamental technological operations, including finishing machining processes. Special attention should be paid to the quality of the material used, the stability and dynamics of the manufacturing process, as well as the precision of the shape and positioning of the manufactured components. During verification, it is crucial to monitor the accuracy class of the gears, including geometric deviations in shape, positioning, and microgeometric surface parameters.

- Proper alignment of the gear pinion and the gear wheel, particularly gear backlash adjustment, is a key factor in ensuring optimal rolling and sliding conditions within the gearing. Inadequate gear backlash can lead to dynamic shocks, resulting in increased dynamic stress on components and the generation of high-frequency vibration and acoustic signals, indicating an improper operational state. Poor meshing conditions, often associated with insufficient lubrication and inadequate oil film formation, can cause premature fatigue damage to contact surfaces. These damages initially manifest as microgeometric changes on surfaces (increased roughness, abrasive wear) and may later develop into more severe damage, such as surface cracks, pitting, or fatigue fractures of gear teeth. Proper gear backlash adjustment, considering specific operating conditions such as rotational speed, load, and operating temperature, has a decisive impact on the dynamics of
