# EVALUATION OF OPERATIONAL SAFETY OF CHOSEN ELECTRICAL SET ELEMENTS IN CONDITIONS OF BIOGAS PLANTS WITH USING OF INFRARED THERMOGRAPHY METHOD

The paper is focused on evaluation of operational safety of chosen electrical set elements in specific conditions of agricultural biogas plants with using of infrared thermography method. The goal of the paper is thermography monitoring of the surface temperature of electrical set elements with detection of high warmed parts. Next goal is evaluation measured temperatures with criteria and requirements of standard ISO 18434-1. In terms of measurement was measured surface temperature of every element and compared with reference ambient temperature. Our study claimed suitability of IRT method for monitoring of electrical set elements. Any of measured objects has high surface temperature. This is significant risk factor for fire and related losses.

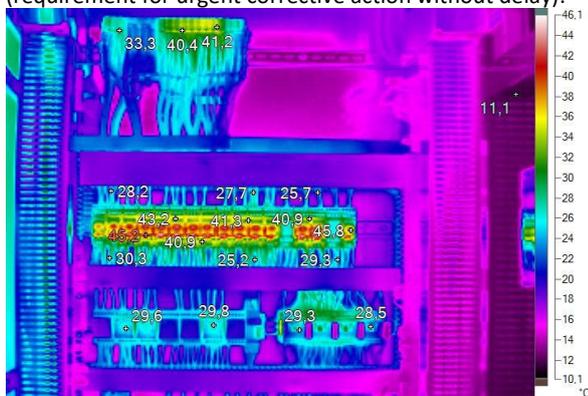
Figure 1. Example of thermogram (biogas plant 1 – machine room)

We can see examples of thermogram at following figures. Next text is word interpretation of thermograms. Fig. 1 shows thermogram of electrical equipment in biogas plant 1 machine room. We can see maximal temperature 45,2 °C of high warmed part. Reference ambient air temperature is 20,0 °C. It is evident that temperature of most warmed equipment is about 25,2 °C higher in comparison with reference temperature. Evaluation in according to ISO 18434-1 is level 3 (requirement for urgent corrective action without delay).

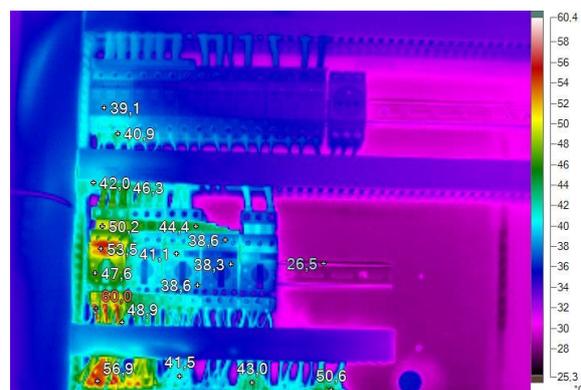
Figure 4. Example of thermogram (biogas plant 2 – machine room)

Fig. 4 shows thermogram of electrical equipment in biogas plant 2 machine room. We can see maximal temperature 60,0 °C of high warmed part . Reference ambient air temperature is 20,0 °C. It is evident that temperature of most warmed equipment is about 43,5 °C higher in comparison with reference temperature. Evaluation in according to ISO 18434-1 is level 3 (requirement for urgent corrective action without delay).

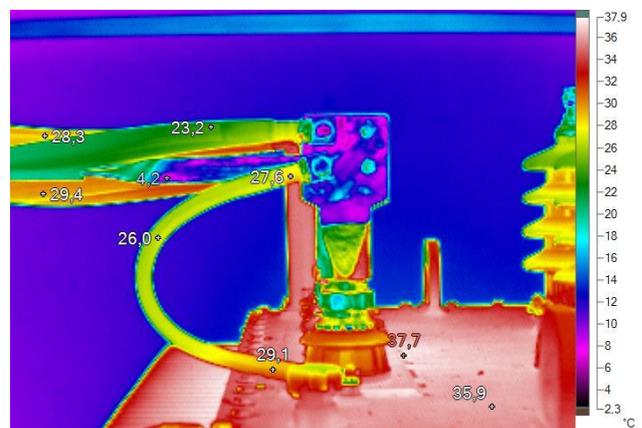
Figure 9. Example of thermogram (biogas plant 3 – transformer object)

Fig. 9 shows thermogram of electrical equipment in biogas plant 3 transformer object. We can see maximal temperature 37,7 °C of high warmed part and temperature of leading wire about 27,0 °C. Reference ambient air temperature is -0,4 °C. It is evident that temperature of leading wire is about 27,4 °C higher in comparison with reference temperature. Evaluation in according to ISO 18434-1 is level 2 (requirement for monitoring and planned correction action).
