EXAMINATION OF DEGRADATION FREQUENTLY REPAIRED SHEARING AND FORMING TOOLS

JOSEF IZAK, MARIAN SIGMUND

FSI VUT Brno, Faculty of Mechanical Engineering, Institute of Welding and Surface Treatments, Brno, Czech Republic

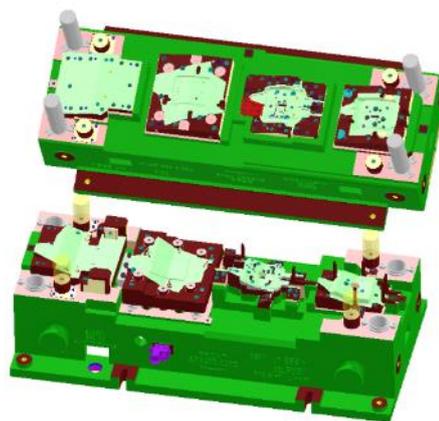
Figure 1. Progressive shearing tool [PWO 2021].

The welded part of the cutting punch, which was the subject of analysis in the article, can be seen in Fig. 3. The inclusion of a part of the cutting punch in the cutting punch can be seen in Figure 2. The whole cutting punch was part of the block of the progressive shearing tool, which can be seen in Fig. 1. It is then placed in the so-called "transfer" press and gradually forms the sheet metal into the final form of the required component. The main dimensions of the cutting punch part (hereinafter only the cutter) are 110 x 90 x 75 mm.

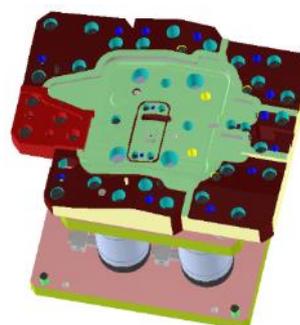
Figure 2. Cutting punch [PWO 2021].

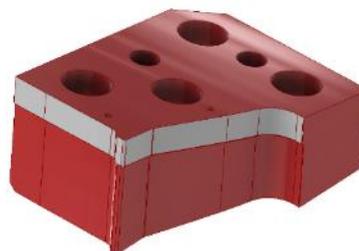
Figure 3. Part of cutting punch [PWO 2021].

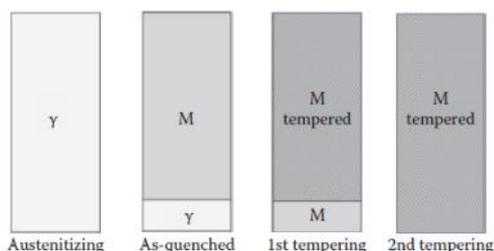
Figure 4. The principle of hardening and tempering [RAFAEL 2016].

To remove a residual austenite multiple tempering is required. Residual austenite begins to transform into martensite when the M_s temperature is reached. To achieve the transformation of all austenite to martensite, a temperature M_f below room temperature must be reached. Alternatively, residual austenite may transform during tempering because precipitation of carbides during tempering reduces the amount of carbon and alloying elements in the solid solution, thereby increasing the temperature M_f . After cooling, part or all the A_2 transforms into martensite. The transformation of residual austenite to martensite is desirable because the proportion of A_2 in the structure can lead to dimensional changes. After the first tempering, the structure consists not only of tempered martensite, but also of fresh martensite. Even a small amount of fresh martensite can affect the overall toughness of the tool. For this reason, it is recommended to temper multiple times. The tool is tempered to a secondary hardness a total of 5 times, at a temperature of 525 °C. The hardening and tempering scheme can be seen in Figure 4 [RAFAEL 2016].

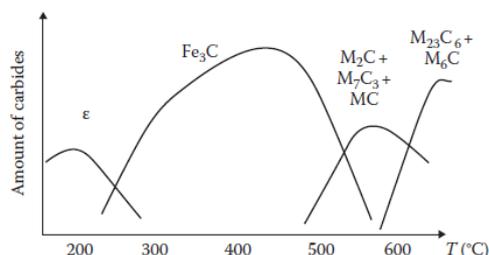
Figure 5. Precipitation of carbides during a tempering [RAFAEL 2016].

During precipitation, the lattice of martensite gradually changes from tetragonal to cubic and carbon diffuses from martensite. Carbon, together with alloying elements (Cr, Mo, V), forms carbides such as M_7C_3 , M_2C and MC (M_4C_3). Secondary carbides prevent the movement of dislocations, thus increasing the strength of the tool. Carbides also have a beneficial effect on the wear resistance of the tool. Figure 5 shows the types of carbides formed at 525 °C during tempering to secondary hardness. The achieved hardness of primary and secondary carbides can be seen in Figure 6 [RAFAEL 2016].

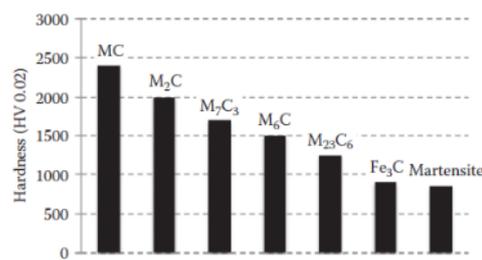
Figure 6. Carbide hardness [RAFAEL 2016].

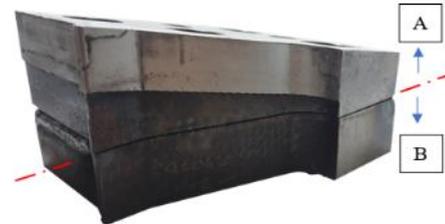
Figure 8. Section of cutting punch.

To produce samples No. 1 (RC 60) and No. 2 (RC 63), the cutting punch was first cut into two parts using EDM technology due to the smallest possible heat affected zone. Figure 8 shows how the section was made. The individual sampling locations can be observed in Figure 9.

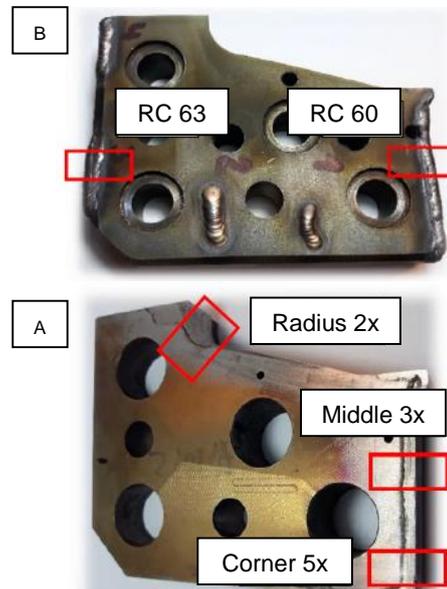
Figure 9. Sampling locations.

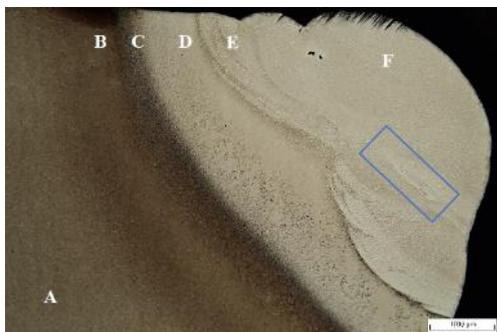
In Fig. 10, at the weld deposit FM RC 60 was used. The width of the HAZ is approximately 2 mm. There are scratches above caused by inconsistent grinding when making a sample. In terms of defects, there are two bubbles or shrinkage cavity at the top. In the blue marked area, you can see a groove through the weld. This is a brighter spot and will probably be a melting point, or touch of the tungsten electrode, when placing the beads.

Figure 10. Macrostructure RC 60, magnification 25,6.

At first, RC 60 and RC 63 were evaluated, where a history of welding is known. In Figures 10, 11, 12 a deposit with an intermediate layer and two final beads can be observed. In both cases, preheating was not included, but it was partially represented by welding the IL. At first sight, it was not possible to accurately identify the laying beads.

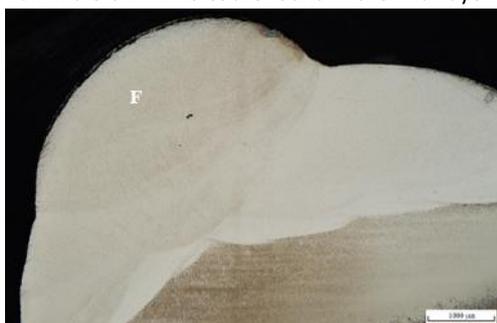
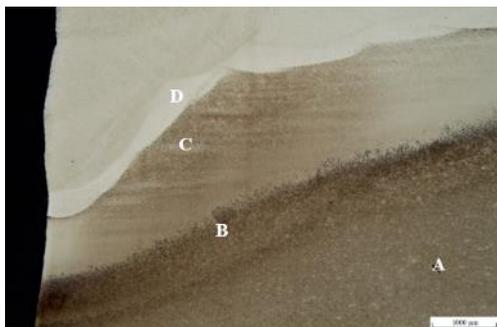
In Figures 11 and 12, FM RC 63 was used as the final layer. The width of the heat affected zone is approximately 1 mm. Compared to the previous weld deposit, its size is smaller due to the use of impulse current, which is also proved by the calculation of the heat input. In the area of the weld deposit, only two small micro-shrink holes are found in the final layer.

Figure 11. Macrostructure RC 63, magnification 25,6x.

Figure 12. Macrostructure RC 63, magnification 25,6x.

In both cases, due to the austenitic intermediate layer, there is a good metallurgical connection of the welding beads, no cracks or imperfect connection of the beads in the dilution area. Defects in the form of bubbles and shrink cavity do not affect the final function of the cutting tool.

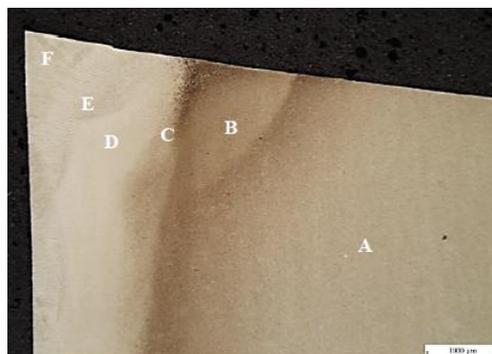
Figure 14 shows the renovated part, which was repaired 3 times. A size of the head affected zone was approximately 1.6 mm. In the deposit there were identified no visible defects. In Figure 15, it was observed a microstructure, which was renovated 5 times. The heat affected zone was significantly larger here than in the previous samples. The width of the heat affected zone was approximately 2 mm. Something that could correspond to a crack indication can be seen in the blue marked area. However, the shape and nature of the spread is very peculiar and will be something else ("possible primary grain boundary").

Figure 14. Macrostructure middle 3x, magnification 25,6x.

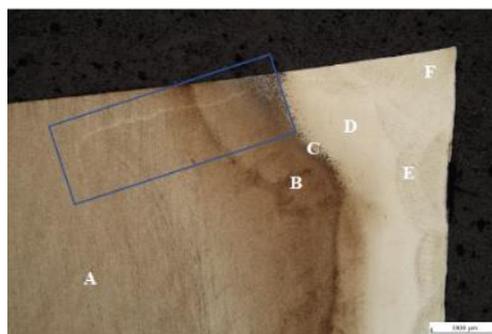
Figure 15. Macrostructure corner 5x, magnification 25,6x.

In the welds there were not any defects which would affect the function of the cutting punch. Looking at BM, you can see how it was shaped according to the bright places that repeat regularly in the lines. From the point of view of the influence of carbide linearity, the tool was suitably oriented, because it achieves the best strength properties just when the direction of the cut was parallel to the forming structure.

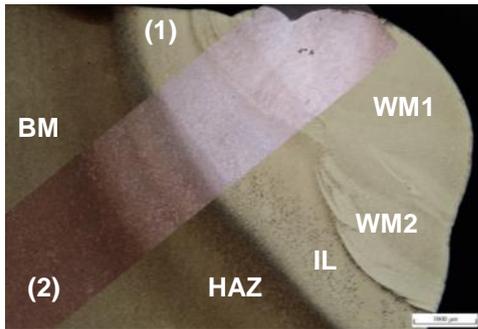
Figure 16 shows the individual marked sites that are observed on the microstructure.

Figure 16. Positions of microstructure RC 60, magnification 25,6x.

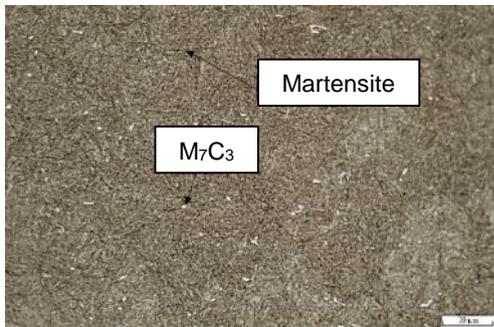
The structure of the base material consisted of martensite, residual austenite and a certain amount of carbides. The most common type of carbide in the structure was the M_7C_3 type, most commonly chromium. Due to the chemical composition, M_2C carbide, mostly molybdenum, also may be present in the structure. To a lesser extent, MC-type carbides (M_4C_3), which were most often vanadium, will appear in the structure. Chromium carbides was likely to be of the secondary type as it dissolves at lower temperatures (500 – 600 °C). Molybdenum carbides, and especially vanadium, can be both primary and secondary. Due to the multiple tempering, no amount of A_2 can be seen in the structure at first sight. Figure 17 shows a sample structure of what most of the BM looks like. The distribution of carbides was homogeneous and no significant carbide linearity was formed, which has a positive effect on mechanical properties and weldability.

Figure 17. Microstructure BM, RC 60, magnification 1000x, (1).

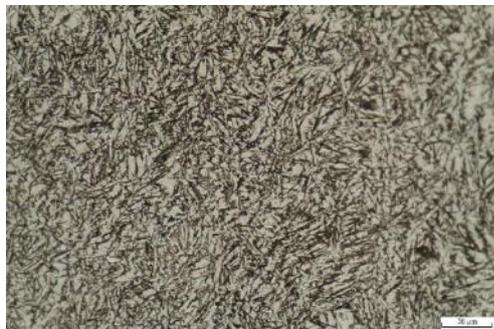
Figure 18. Microstructure HAZ, RC 60, magnification 1000x, (1).

In Figure 18, we can see the microstructure of HAZ. Looking at the structure, it is very likely a coarse plate martensite with a relatively high proportion of residual austenite. The reason should be the diffusion of nickel during melting into BM, where plate martensite was being formed. Residual austenite was tough, but there was also a high proportion of plate martensite. If stress would be created during welding, microcracks may form, initiate, and reduce the life of the weld deposit.

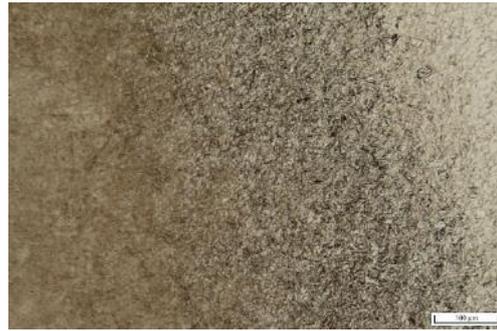
In Figure 19, this transition can be observed at lower magnification. The area of the plate martensite in the case of this weld deposit was approximately 550 μm .

Figure 17. Microstructure HAZ – IL, RC 60, magnification 250x, (1).

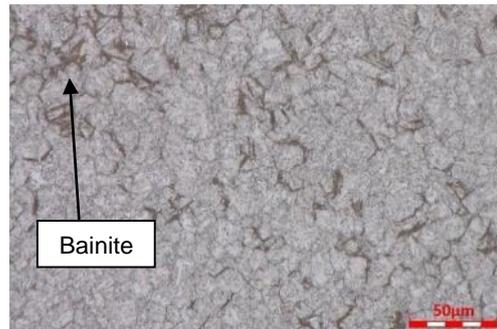
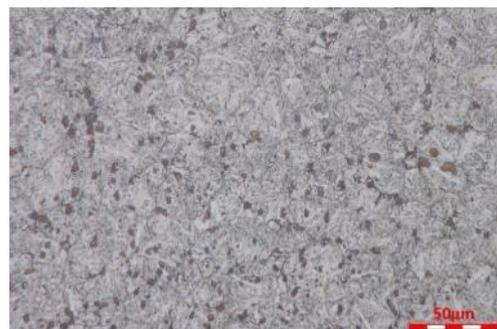
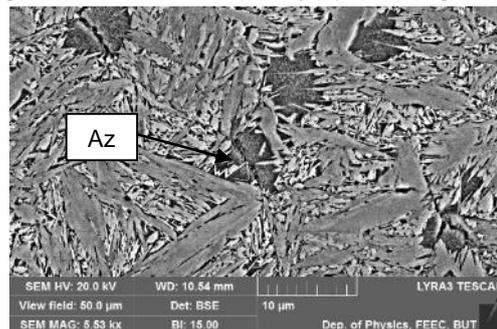
The structure of the IL should be duplex after welding, according to the material sheet. However, during welding, the weld pool was relatively large and there was probably a large dilution, partial diffusion of Cr and Ni into the base material and the upper final weld deposit. Nickel was not sufficient to stabilize the austenitic structure. After welding, the structure of austenite, martensite and bainite was formed along the grain boundaries (dark brown). There was also partial precipitation of carbides in the intermediate layer and the structure that was originally tough is relatively hard now. Figure 18 shows the structure of the IL upper part. Figure 19 pictures the lower part of the IL, where the “brown dots” were an etched structure of residual austenite. The evidence can be seen in Figure 20, where martensite needles “shoot” through residual austenite.

Figure 18. Microstructure IL (upper part), RC 60, mag. 1000x, (2).

Figure 19. Microstructure IL (lower part), RC 60, mag. 1000x, (2).

Figure 20. Microstructure IL (lower part), RC 60, mag. 5530x, (2).

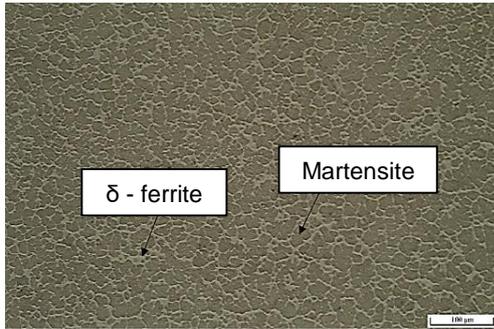
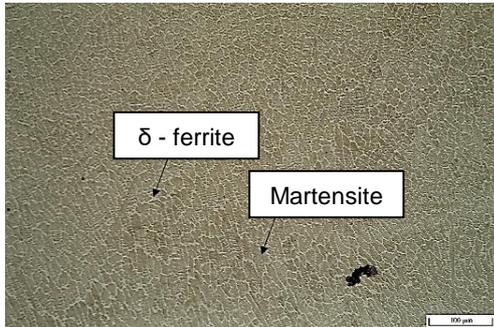
Figures 21 and 22 both depict the structure after welding with the FM RC 60 and RC 63, as the final weld beads. The structure of the weld deposit should consist of martensite, a proportion of residual austenite and carbides. From the images on both structures, we can see a network around the martensite. This was most likely the delta ferrite phase, which is the soft phase. In the case of dynamically stressed components, the delta ferrite phase is favorable because it imparts toughness to the weld deposit and the carbides together with martensite form a sufficient hardness. In the case of a shearing tool whose application primarily requires high wear resistance, the proportion of delta ferrite is undesirable.

Figure 21. Microstructure WM, RC 60, magnification 250x, (1).

Figure 22. Microstructure WM, RC 63, magnification 250x, (1).

Comparing Figures 21 and 22, we get a result that the proportion of delta ferrite was higher in the weld metal renovated with wire RC 60. From the point of view of the excluded microstructure for a given application of a shearing tool, the wire RC 63 achieves a higher quality. According to the equilibrium diagram Fe - Fe₃C, delta ferrite is stable only at high temperatures (above 1392 °C). However, with a certain ratio of austenite-forming and ferrite-forming elements, this high temperature phase can become stable even at normal temperatures. The Fe - C - Cr diagram (8 % Cr) was used to approximate the possible delta ferrite phase in the weld metal. When carbon is plotted in the graph according to Tables 5 and 7 on the x-axis, it can be seen that the curve passes through delta ferrite areas during solidification and this structure can be eliminated in the weld deposit. The diagram is only for chromium, other ferrite-forming elements contained in the wire are not included here, which would further expand the delta ferrite zone.

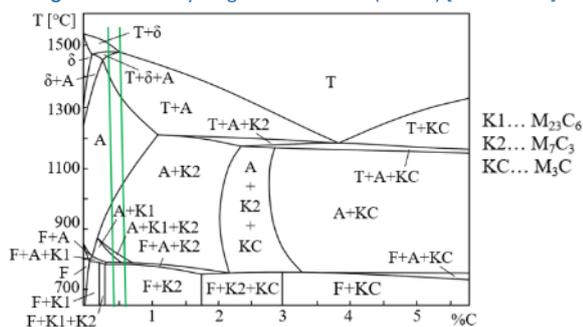
Figure 23. Ternary diagram Fe - C - Cr (8 % Cr) [JURCI 2009]

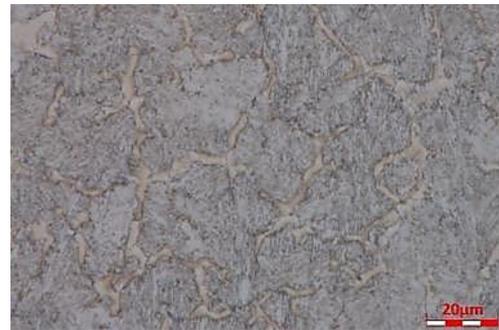
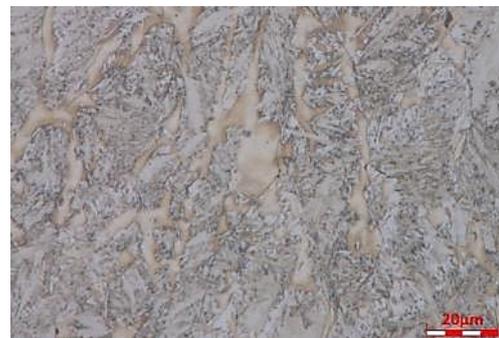
The structure of the final weld bead (WM 1 and WM 2) can be seen at higher magnification in Figures 24 and 25. In the upper area (WM 1) the structure was "polyhedral", while in the lower area (WM 2) the structure was "columnar". Everything from the melt is coarse, which was the case with delta ferrite observed in the structure.

Figure 24. Microstructure WM1, RC 60, magnification 2000x, (2).

Figure 25. Microstructure WM2, RC 60, magnification 2000x, (2).

To increase the service life of the cutting punch, the tool should be heat treated (partial austenitization + tempering to secondary hardness). This would dissolve the delta ferrite phase and the structure would then be formed by martensite with a larger amount of carbides, which would increase the wear resistance and blade grip. The problem could occur with dimensional changes of the tool during heat treatment (phase transformation).

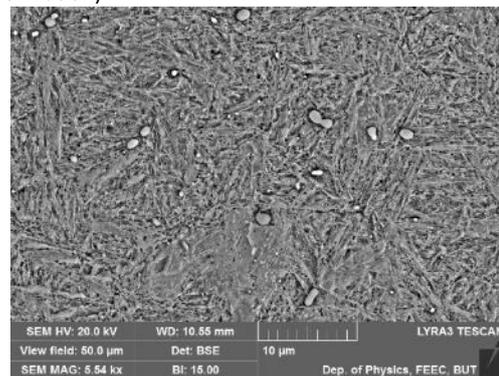
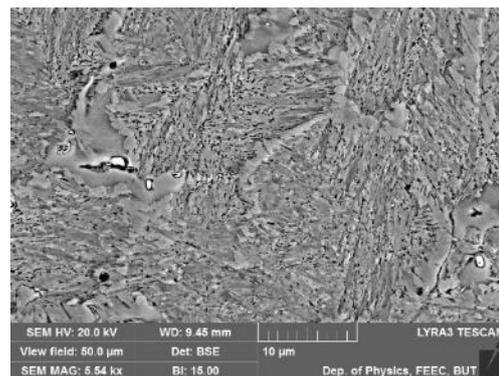
Figure 26. Microstructure BM, RC 60, magnification 5540x, (2).

Figure 27. Microstructure WM1, RC 60, magnification 5540x, (2).

For comparison, Figure 26 shows the original structure that formed the tool geometry (martensite, a small amount of A_2 and carbides) and Figure 27 shows the tool structure after welding FM RC 60 (martensite, AZ, delta ferrite and a small amount of carbides). Thanks to the heat treatment, the "original" structure would be restored, and the tool life would be increased 2 to 3 times. Due to the size of the carbides in the BM, the homogeneous arrangement in the structure, the small proportion of A_2 , no fundamental dimensional changes should occur, and the heat treatment designed in this way would be theoretically feasible.

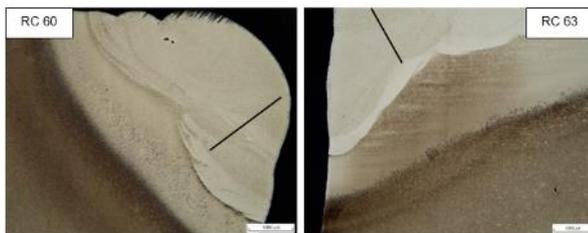
First, the value of the final weld metal layer (WM) was measured on samples RC 60 and RC 63, whether it reaches the guaranteed hardness declared according to the material sheet. Figure 28 shows the location of the puncture line. For evaluation, 9 hardness values were measured for each weld deposit and an arithmetic average of these values was performed. The resulting value was compared with the values from the material sheet. According to Table 11, the required hardness was achieved in both cases.

Figure 28. Location of hardness measurement lines.

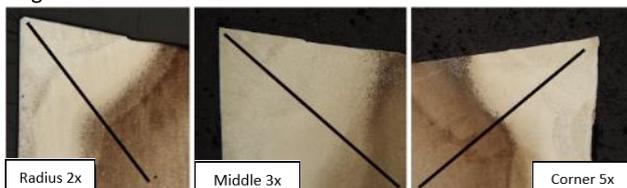
One of the main points was to limit the implementation of inefficient repairs. For this reason, the hardness in the "sub-weld" zone was measured. Samples No. 3, 4, 5 were taken from the cutting punch after a certain number of renovations in order to find out what effect the continuous renovation of the cutting edges has on the degradation of the BM structure. For assessment, samples were taken from places after 2, 3, 5 renovations. Figure 29 shows the points where the puncture lines were drawn. The line was always drawn from the cutting edge towards the HAZ.

Figure 29. Hardness measurement line.

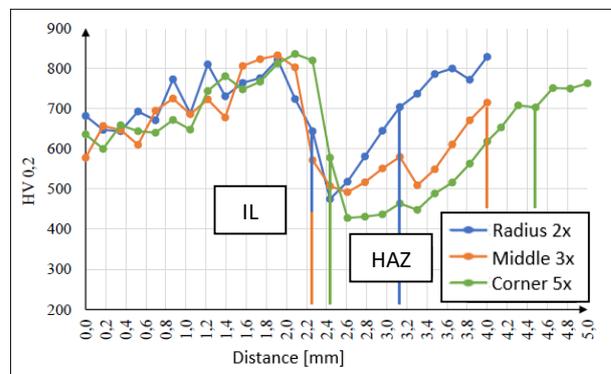
Figure 30 shows a graph of the measured hardness of each sample as a function of the line. When measuring the hardness, a picture of the microstructure was always taken after the indenter impression. Based on the hardness values and individual images from the puncture sites, the approximate HAZ

range was determined. Figure 30 shows where the heat-affected zone on each sample begins and where it ends. Also, we can see that with increasing number of welds, the hardness value in HAZ decreases and expands. In Table 12 are the values of the size of the heat-affected zone after subtraction from the graph.

Figure 30. Hardness graph over puncture distances.

Obviously, this cannot be applied globally, and this information can be taken as a precedent. It is affected by many other influences that are not included in the experiment, such as the extent of renovation, the effect of the current used, the welding speed, etc. The heat affected area will not expand indefinitely, but what will likely to happen is that the hardness of the BM will keep decreasing. The reason for researching this phenomenon was to create an idea of how the heat-affected zone and based material will behave during multiple welding.

Another interesting thing that can be observed already in the evaluation of the microstructure was the reinforcing effect of the intermediate layer. One of the problems was the dogma that the IL is tough, and the final hard layer must not be machined during machining so that we do not lose the hardness of the cutting edge. As can be seen from the graph, the intermediate layer strengthens significantly after welding the final hard layer.

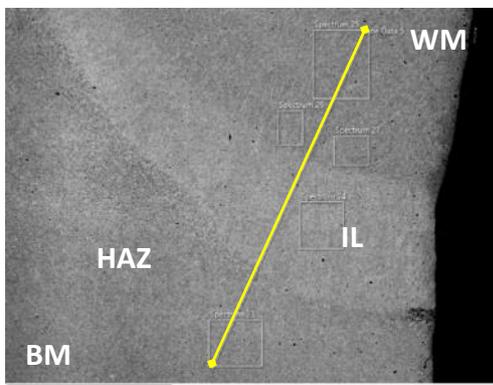
During the observation of the macrostructure and microstructure, it was not possible to determine the position of the intermediate layer at first sight. When measuring the hardness, it can be seen in Figure 30 that strengthening occurs at the point where the interlayer should occur. For this reason, a chemical microanalysis was realized. The analysis was performed on samples RC 60, RC 63, and corner 5x. On samples RC 60 and corner 5x were likely to occur dilution and the IL as such was not exactly identifiable. Figure 31 shows the line analysis of sample RC 63. In Figure 32, we can see a remnant of undiluted intermediate layer. Chromium increased in the range of 300 to 800 μm . It can also be observed that the nickel dilution (diffuses) after welding into the final weld metal layer and partly into the BM. For this reason, the duplex structure was unlikely to stabilize, and the interlayer strengthens. Due to the scope of the article, only the analysis of the RC 63 sample was included here.

Figure 31. Line analysis, RC 63

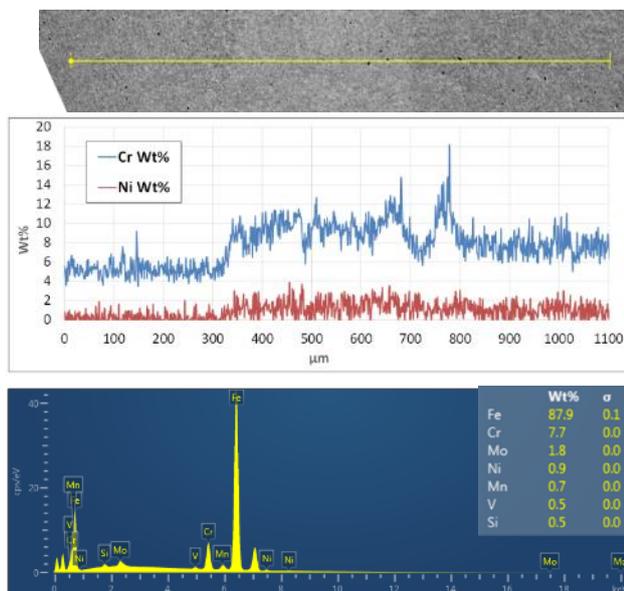
Figure 32. EDS analysis results of sample RC 63
