A COMPARISON OF NON-DESTRUCTIVE DEFECT DETECTION METHODS FOR STEEL WIRE ROPES

DOI: 10.17973/MMSJ.2024_06_2024012

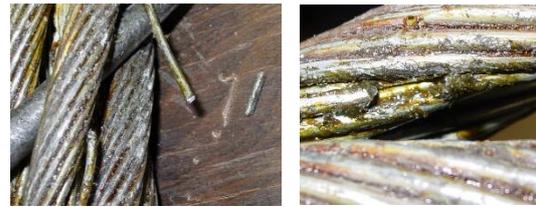
In the case of the third reference sample of the damaged wire rope (R3), a wire with a diameter of 2.36 mm was broken inside the rope at a distance of 1200 mm from the left end of the rope (Fig. 5a), i.e., a decrease of 0.8 % in the load-bearing cross-section. Further damage was created in this sample by cutting out a wire with a length of 30 mm from inside the rope, i.e., a decrease of 0.8 % in the cross-section.

Figure 5b. A photo of artificially created internal defects

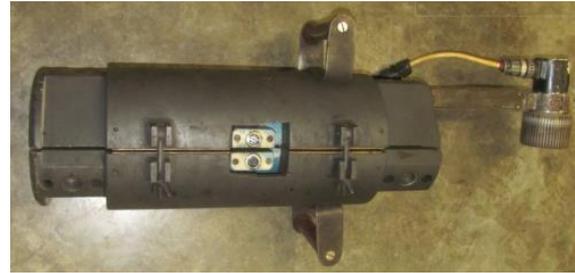
The MID-3 magnetic defectoscope (see Fig. 8) was developed at the Institute of Coal Research in Ostrava-Radvanice, Czech Republic, in the 1980s. Technical parameters of this defectoscope are mentioned in Tab. 2. This type of defectoscope is still in use today; in a modernised and digitised form, naturally. Both the excitation (generation) and detection of the magnetic field are ensured by induction coils. Older types of devices used only one wide and one narrow coil for defect detection; newer defectoscopes have a larger number of both coils. At the turn of the millennium, many of these instruments were digitized. As they are robust, durable devices of simple construction, they are still frequently used in this country and abroad, especially in Slovakia. Along with the REMA defectoscope, both of these devices

Figure 8. MID-3 defectoscope
