# WEAR OF FUNCTIONAL PAIRS OF A GASOLINE ENGINE COMBUSTION CHAMBER

Gasoline combustion engine is generally the most important part of a car. With this driving unit the car achieves the best ratio between its fuel utilization and weight. In order to comply with required parameters, such as performance, ecology and economy of combustion engines, their regular service inspections and associated maintenance operations must be followed. For testing the operability of these engines, especially for testing the wear of functional pairs of the combustion chamber, we use various methods. The paper deals with detection of wear of combustion engine functional pairs and with subsequent comparison of obtained values with the values declared by the manufacturer. The measurements were carried out on a Suzuki gasoline engine G13BA with a cubature of 1298 cm<sup>3</sup> and a total mileage of 160,000 km.

The analysis of the safety of employees in railway transport is in order to determine the wear of functional pairs of the gasoline engine combustion chamber, we had to select a suitable measuring object. Measurements were therefore carried out on a Suzuki gasoline engine G13BA with a cubature of 1

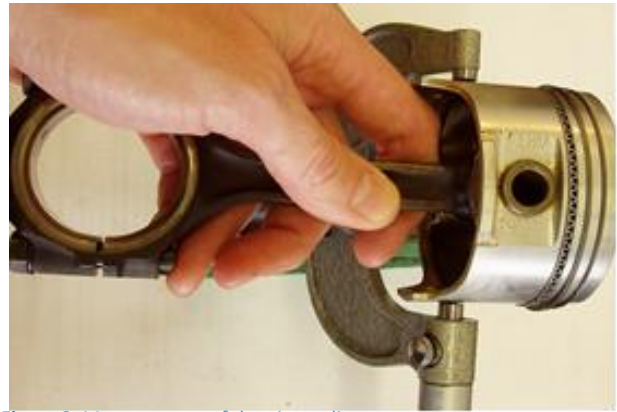
Further measurement concerned the piston diameter and it was measured by the micrometer. Here the manufacturer's instructions had to be observed again, i.e., at a distance of 15 mm from the piston shell edge (on the crankshaft side) in a direction perpendicular to the piston pin (Figure 2). Measurements were carried out on all pistons.

**Figure 2.** Measurement of the piston diameter

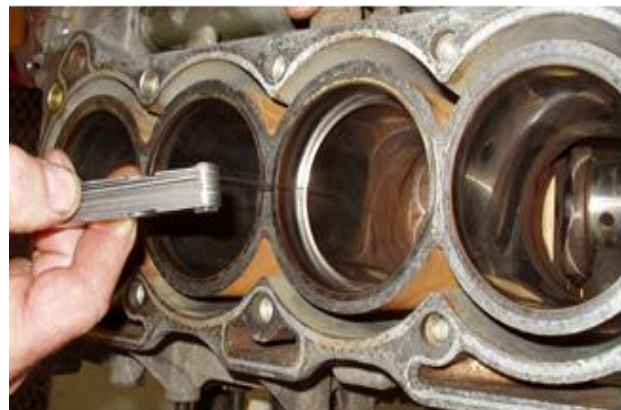
Functional pairs: cylinder - piston ring and piston ring - piston groove was examined by measuring their clearance in the locks. First, we examined clearance in the locks of piston rings in cylinders. Prior to measurement it was necessary to remove and clean carbon deposits from piston rings in order to obtain most objective values. Subsequently, the piston rings were inserted into the cylinder according to manufacturer's instructions, i.e., 10 mm from the cylinder edge (from the cylinder head side). The measurement was carried out by means of thickness gauges inserted into piston ring locks (Fig. 3). By the last measurement we determined the piston ring clearance in the piston groove (Fig. 4).

**Figure 3.** Measurement of piston ring locks clearance in a cylinder

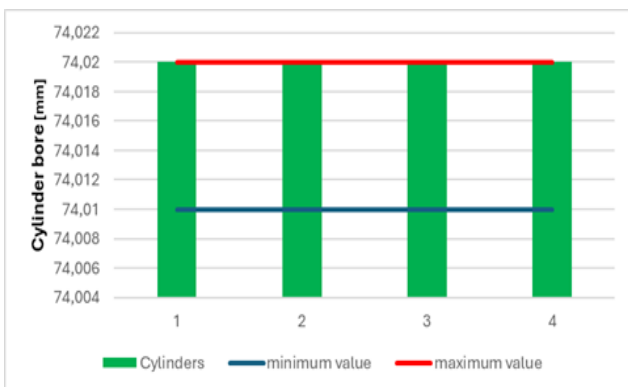
displays an average value which was calculated from each measured value of individual cylinders, and further they are listed with the permissible interval in Figure 5. The permissible value prescribed by the engine manufacturer represents the interval 74.01 - 74.02 mm.

Figure 5. Comparison of inside diameters of cylinders with permissible interval

From graphical comparison of measured values with the permissible interval given by the manufacturer we can see that all four cylinders are within the maximum prescribed tolerance. The second series of measurements represents the values measured from average of individual pistons and is shown in Figure 6. The permissible value prescribed by the manufacturer is given by the interval 73.98 - 73.99 mm.

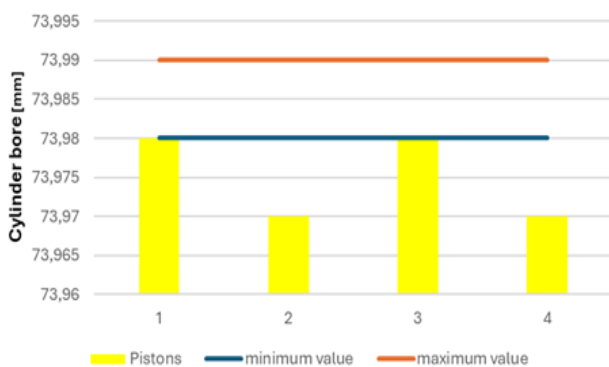
Figure 6. Comparison of diameters of cylinders with permissible interval

From graphical comparison of measured values with the permissible interval we can see that the pistons No. 1 and 3 are within the allowed interval. The pistons No. 2 and 4 showed lower values than those prescribed by the manufacturer.

The paper describes and documents the detection of functional pairs wear of the Suzuki G13BA gasoline engine combustion chamber with a cubature of 1298 cm<sup>3</sup> and a total mileage of 160,000 km. After dismantling of the engine, we found that the piston diameter of the second and fourth cylinder was outside the manufacturer's prescribed tolerance [Kuric 2011]. Inside diameters of cylinders did not show values outside the prescribed tolerance. The second and the fourth cylinder showed values of clearance of the cylinder - piston pair outside the tolerance. The cylinder - piston ring wear was close to limiting values, but no limiting values were found on functional pairs: piston - piston ring. As a result of these facts, compression pressure may gradually decrease, causing worse starting, lower output and higher oil consumption [Bozek 2021]. Based on these results, the selected gasoline engine needs reparation in the near future in order to avoid its emergency state.

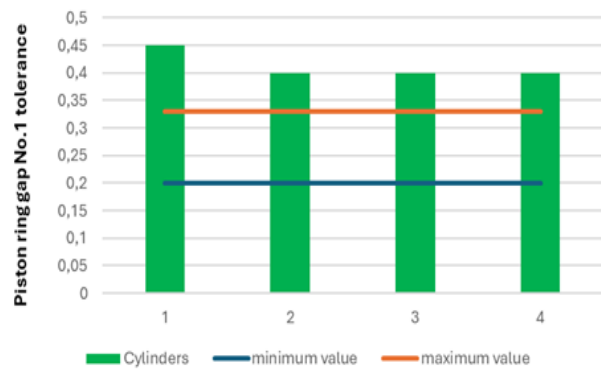
In the third series of measurements, we checked the functional pair cylinder - piston ring No. 1. The measured values of piston ring locks clearance of all cylinders are shown in Figure 7. The permissible prescribed interval is between 0.20-0.33 mm with a limiting value of 0.7 mm. From a graphical representation we can see that the clearance in all piston ring locks is outside the permissible interval, even they have not yet reached the limiting value.

Figure 7. Comparison of piston ring locks No. 1 with permissible interval

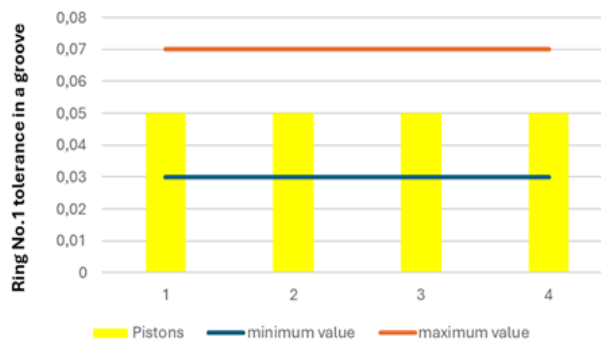
The last series of measurements was performed on functional pairs of the piston ring No. 1 in the piston groove on each cylinder where their clearance was examined. All measurement results are shown in Figure 8. The permissible prescribed interval is 0.03 - 0.07 mm. All four measurements of clearance on the ring No. 1 fell into the prescribed interval.

Figure 8. Comparison of piston ring No. 1 clearance in a groove with permissible interval
